**McCabe Home Inspection Services Inc**  
 Lake Worth FL  
 Licenses HI901 CBC058559 CCC058824 CPCO JF112319  
 Ph#: (561) 547-9870

Doc #: Inspector: David McCabe

Date: 3/22/2019

Dwelling Address: 1975 Claybridge Circle  
 West Palm Beach, FL

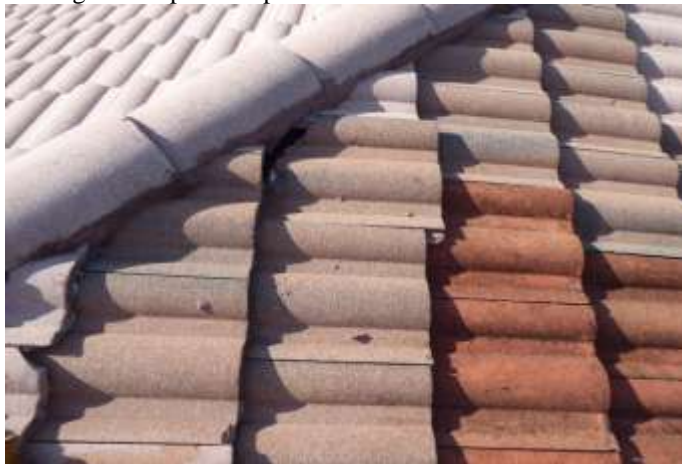
Step #	Component	Rating	Comment
12.	Method of Inspection		Walked on.
13.	Estimated Age		Hip roof. Main roof is original @20 yrs.  Older / original roof approaching the end of its life expectancy. Client is advised to budget for repairs / replacement in the near future.

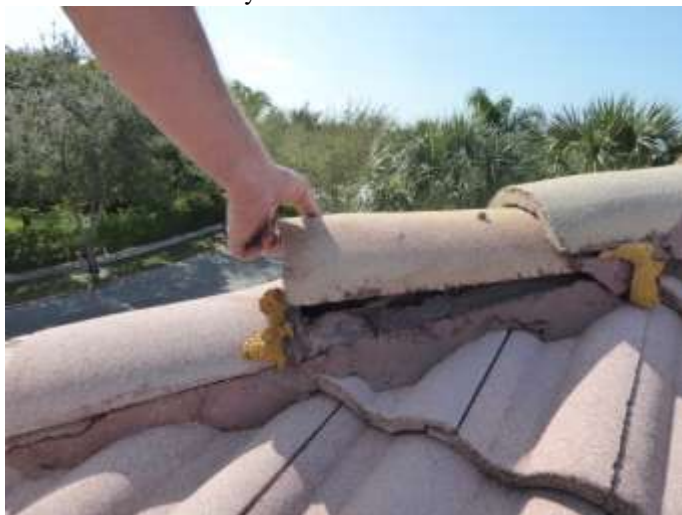
| 14. | Main roof covering | Needs Repair | Spanish S tile. Average life expectancy: 20-25 yrs. Prior un-professional repairs were noted on roof over several locations. Follow-up with seller for explanation and any receipts / warranty information from licensed roofer. If licensed roofer was not used there is a high probability that the repairs were not done correctly. |

Broken / slipping roof tiles (8-10) exposing roof covering to direct sunlight. Loose tiles need to be re-adhered to roof surface using proper adhesive and per the manufacturer and the Florida Roofing, Sheet Metal and A/C Contractors Association (FRSA) broken tiles must be replaced. Tiles shed water and protect roof membrane from UV sunlight to provide 20 year + life expectancy. Tiles are required by the building code to be firmly attached to roof to prevent sliding down roof or flying off during high winds.

Loose hip and ridge cap tiles at scattered locations. Roofer must check all and re-glue loose tiles. Tiles are required to be attached to roof surface to prevent flying off in high winds.

Foam adhesive is exposed to sunlight at several locations on roof. Per the manufacturer foam adhesives cannot be exposed to sunlight and must be covered to prevent quick deterioration.

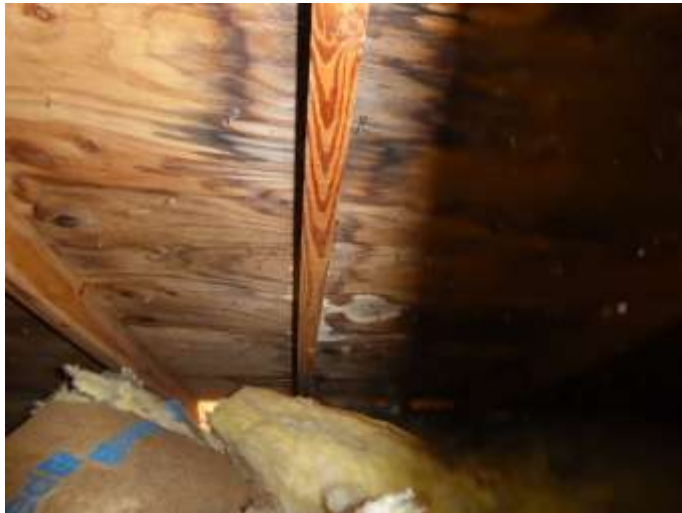
| 24. | Sheathing | Needs Follow Up | Plywood, 5/8. Leak stains / wood rot were observed over master bedroom in attic. No evidence of repair was noted on the roof above the locations. Follow up with seller for any repair receipts. If no proof of repair by licensed roofer, leakage must be considered active. |

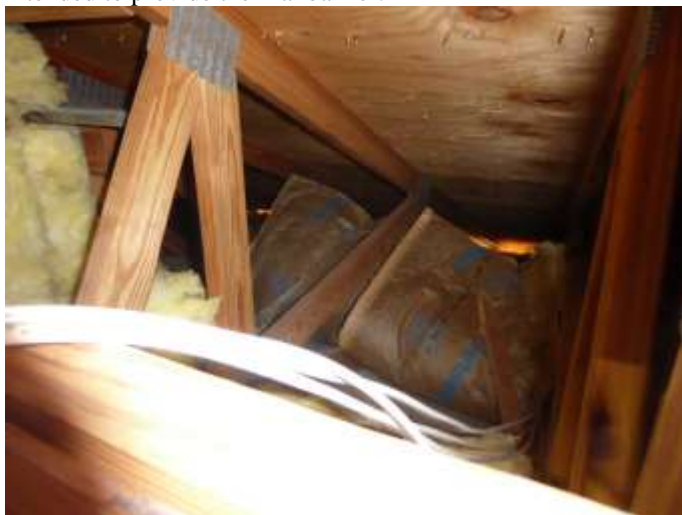
| 25. | Insulation | Needs Repair | Fiberglass batt. Insulation has been removed / disturbed over master bedroom, front bedroom and dining room by workman. Insulation needs to be re-installed as intended to provide thermal barrier. |

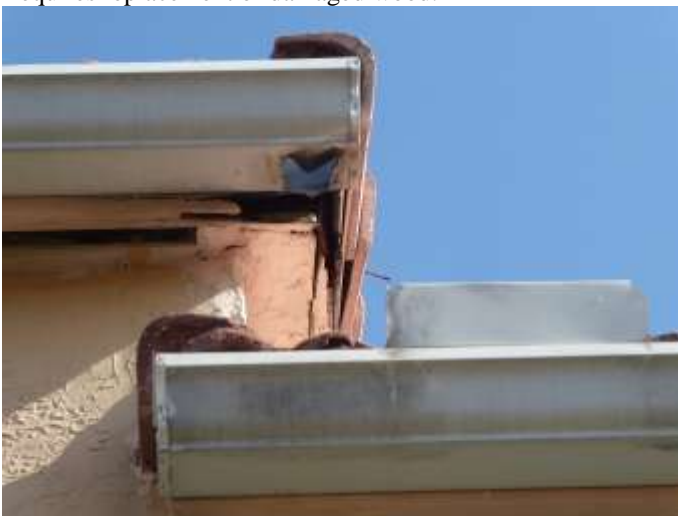
34. Fascia/soffit Needs Repair Wood / stucco. Rotted wood at several locations on front and rear of house. Requires replacement of damaged wood.

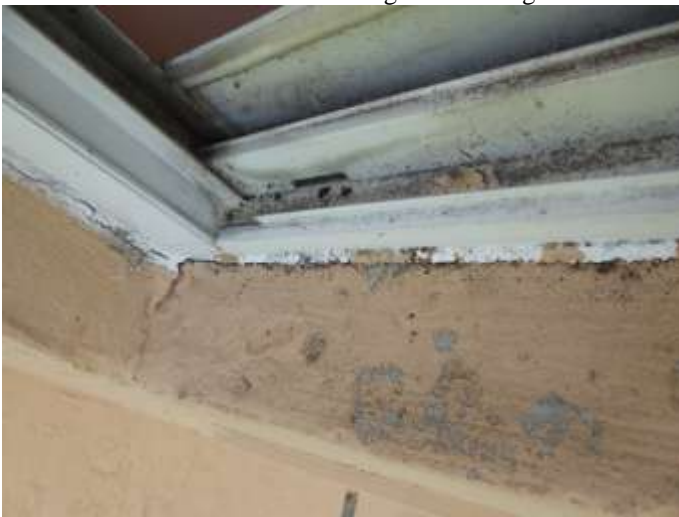
| 37. | Windows | Needs Repair | <p>Single hung aluminum framed windows.</p> <p>Caulking has failed / separated at most window and door frames. Repair person must check each window and re-caulk as necessary. Removing old caulk, cleaning the area to be caulked and using a polyurethane caulk will produce the best results. This is not a maintenance issue as it is required to prevent water intrusion into walls which will result in damage and mold growth.</p> |

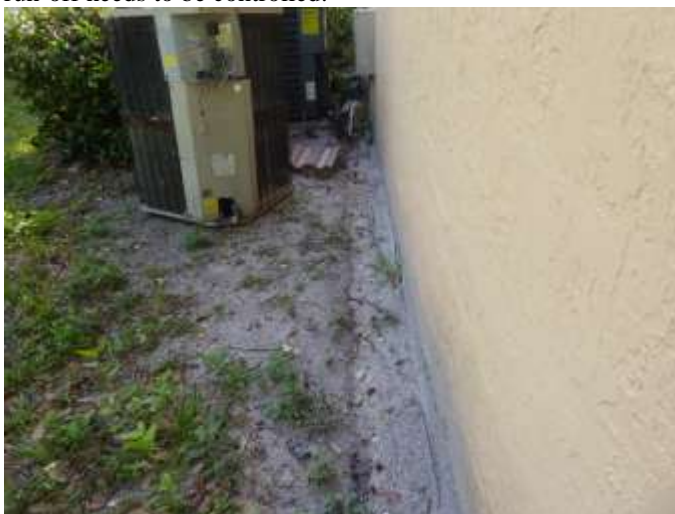
Step #	Component	Rating	Comment
42.	Grade away from structure	Needs Repair	Erosion of soil from roof water runoff at right side and rear of house. Water run-off needs to be controlled.

Ground not sloping away from structure as required at right side and rear (1 inch slope per foot for first 6 feet). These areas need to be re-graded as water accumulating at foundation can cause excessive settlement and structural problems.

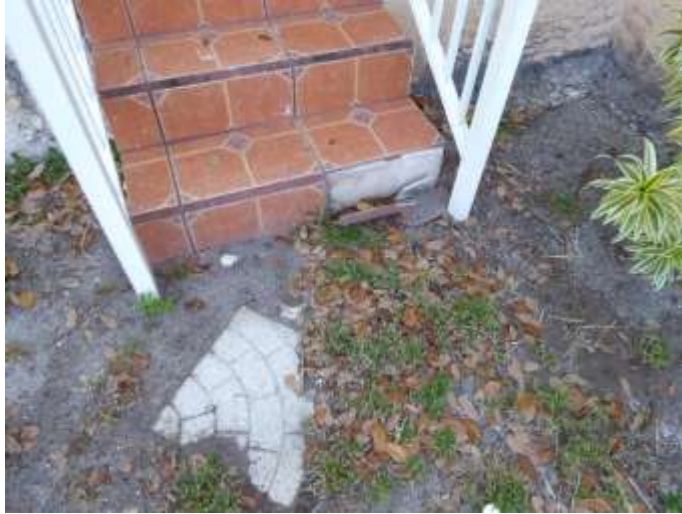
46. Patio Needs Repair Backyard, Concrete slab. Steps. Loose tile at rear patio.

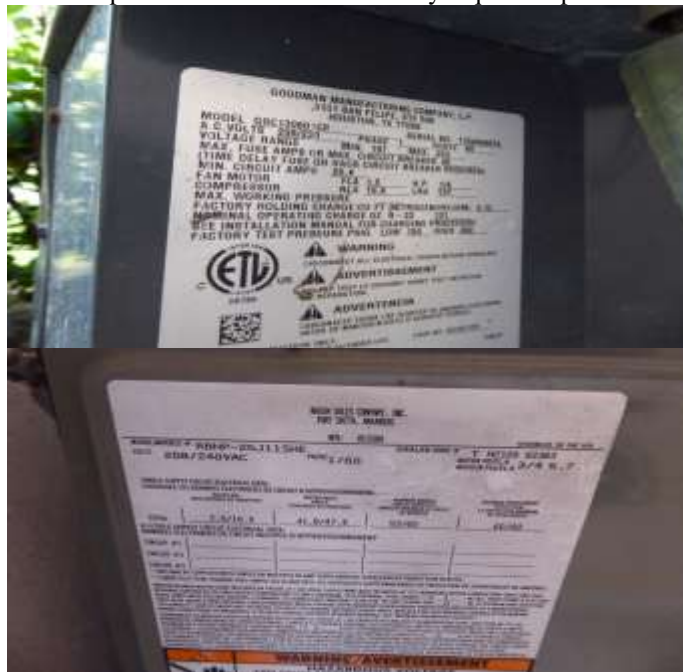
Step #	Component	Rating	Comment
62.	A/C type	Needs Repair	Central air, Split system, 5 tons. Air handler is 10 yrs. Condensing unit is 8 yrs.

Mismatched A/C equipment. The building code prohibits replacing components of the A/C system unless they can be proven to be compatible. This installation was done illegally with-out a permit and usually results in low efficiency and higher electric bills. Follow-up with local building department for required permit and code compliance. This mismatch usually requires replacement of A/C system.

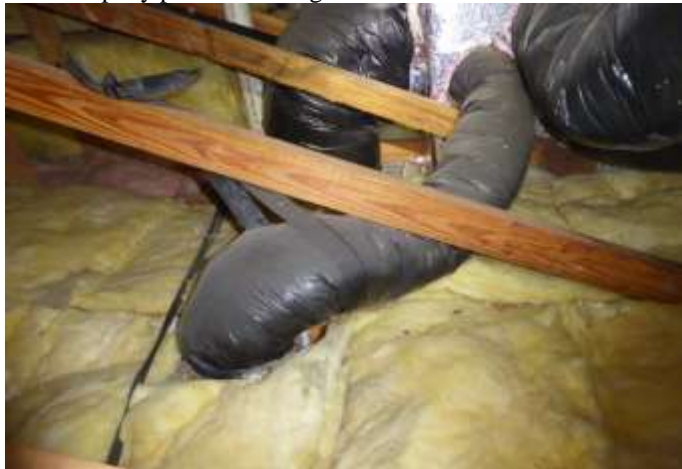
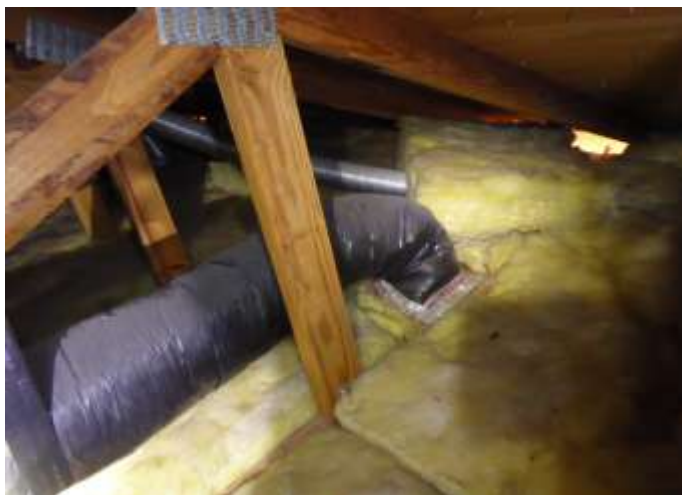
63.	A/C operation	Inoperable	Air-conditioning system not responding to controls-not operational. Requires evaluation and cost estimates prior to closing by licensed A/C contractor.
64.	Heating operation	Functional	
65.	Fuel supply	Functional	Electric.
66.	Distribution	Marginal	Flex duct / Ductboard. Some ductwork was not hung properly off attic floor supports have broken and is in contact with other ducts / insulation. The ductwork must be supported sufficiently to prevent leaks at connections and sagging of more than 1/2" per foot. Requires evaluation and repair cost estimate by licensed A/C company prior to closing.

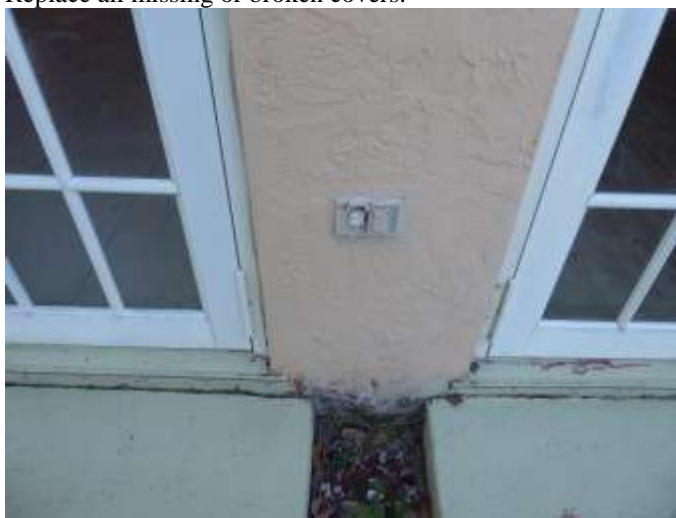
88. Exterior electrical Needs Repair Receptacles are missing required weatherproof covers at rear and right side. Replace all missing or broken covers.

Broken conduit at A/C condensing unit, wiring is exposed.

Unsealed light fixtures / receptacles. Caulking is required to seal open gaps on all sides except the bottom of exterior wall mounted light fixtures and receptacle covers. Seal all to prevent water intrusion into walls.

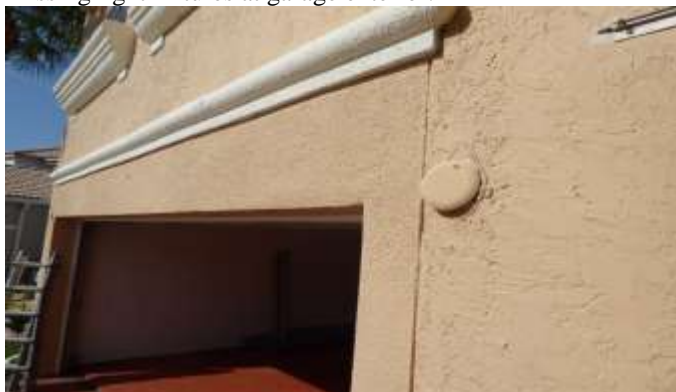
92. Light fixtures Needs Repair Missing light fixtures at garage exterior.

Inoperable light fixture at 1st floor hallway and exterior flood lights.

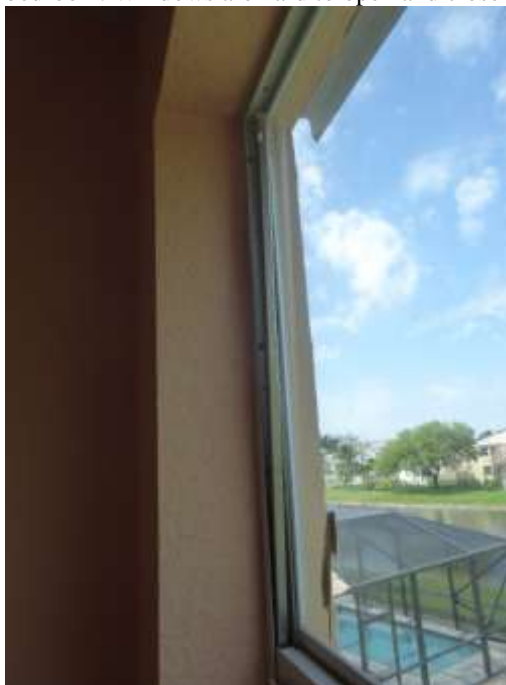
Broken window sash springs at dining room, both 2nd floor bedrooms and master bedroom. Windows are hard to open and close or will not stay up.

Broken / loose glass not performing as intended at 2nd floor bedroom needs replacement. Window sash is half out of frame at this location.

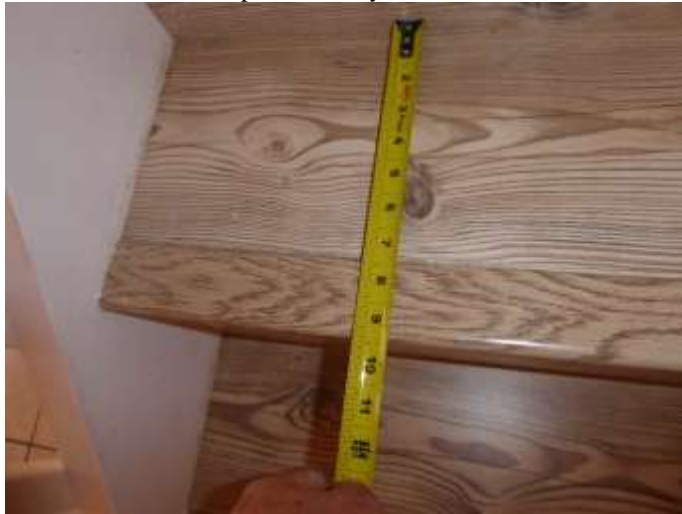
103.    Stairs / Railings    Needs Repair    Wood. Improper modifications during the installation of the flooring on the stairs have made them non code compliant. The building code requires a tread to be a minimum of 10" in depth for safety.

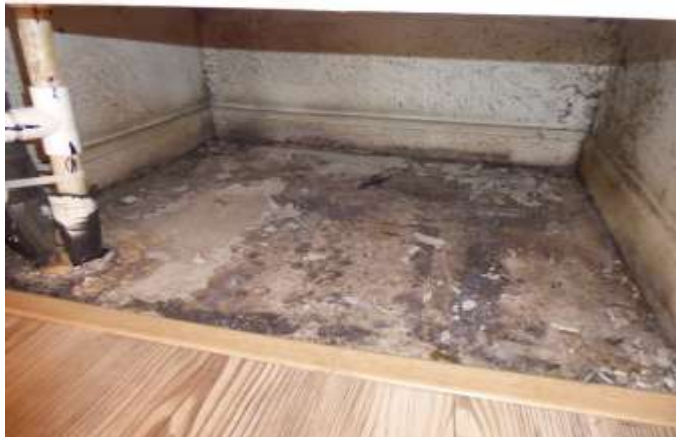
Visible discoloration / suspected microbial growth at 2nd story air handler closet. Per state law this requires further evaluation by licensed mold remediator prior to closing to determine the extent of the contamination problem and provide complete repair cost estimates prior to closing. Molds have been proven to cause health problems to the very young, person's with allergies and or weakened immune systems. Certain types of mold have even been proven to cause health problems to healthy individuals. Per the EPA all contamination and associated damaged materials must be removed and replaced.

Water intrusion into walls can cause hidden damage and mold growth inside walls. This situation requires further evaluation by a contractor licensed in mold remediation PRIOR to closing for mold contamination and HIDDEN damage. All associated damage must be found and repaired. All problems which can allow water intrusion need to be repaired ASAP.

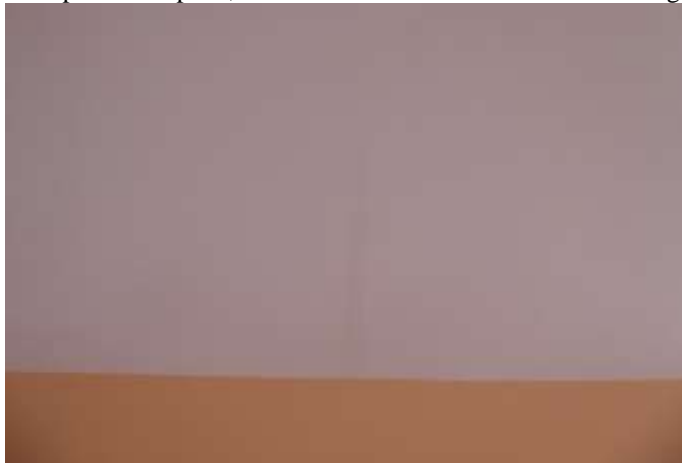
Water stains dry at time of inspection when tested with moisture meter at 1st floor bedroom, dining room, living room, master bedroom and family room ceilings above French doors. Follow up with seller for repair receipt / explanation. If no proof of repairs, stains should be considered active leakage in need of repair.

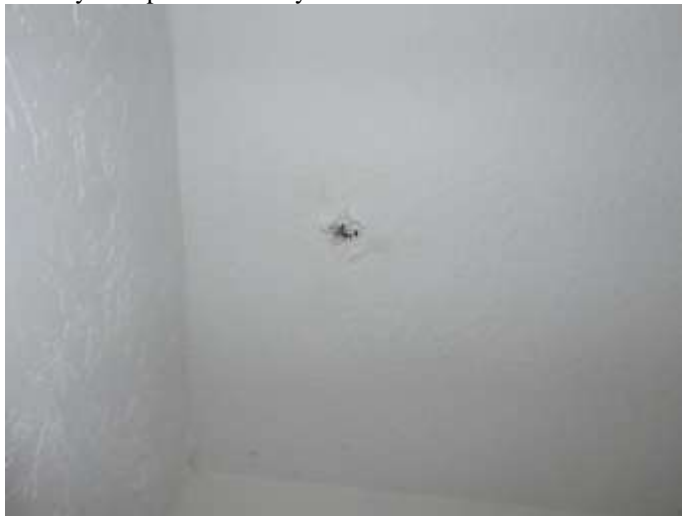
Prior repair and water damage to ceiling in garage above water heater and at front wall of garage. Follow-up with the seller for an explanation / more information and any receipts or warranty information.

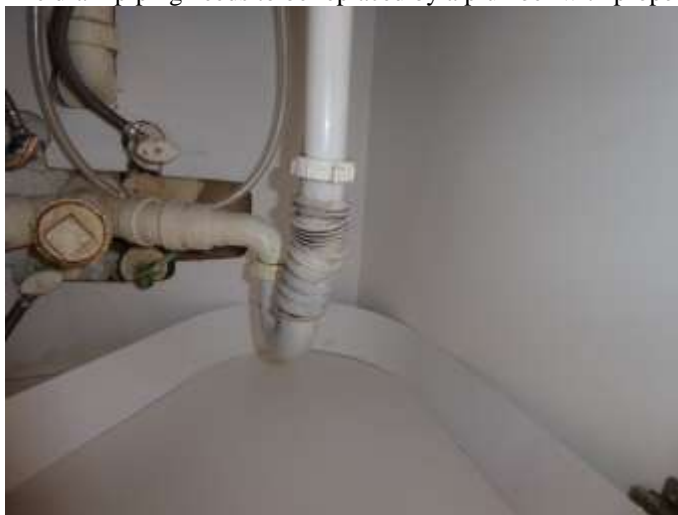
Step #	Component	Rating	Comment
135.	Cabinets	Needs Repair	Binding cabinet glass door needs hinges adjusted.  Loose cabinet above refrigerator in the kitchen.
136.	Sink plumbing	Needs Repair	Improper materials / amateur workmanship to drain pipe under kitchen sink. Drain lines are required to be smooth on the interior so they don't trap and hold solids. The drain piping needs to be replaced by a plumber with proper materials.

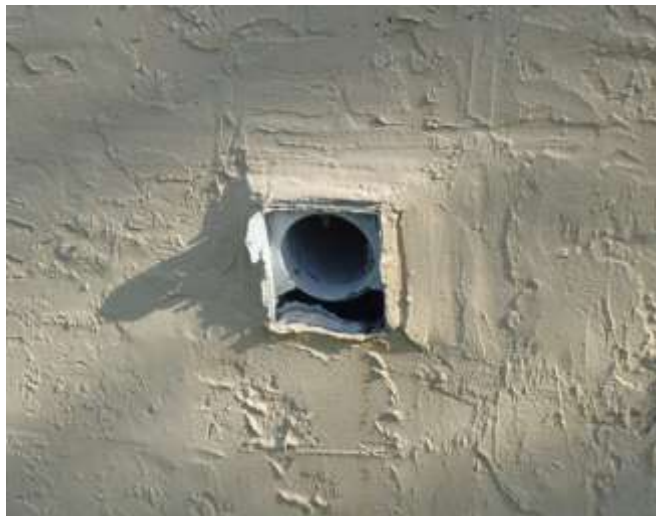
Dryer exhaust hood

139.	Microwave	Needs Follow Up	
140.	Refrigerator	Functional	
141.	Icemaker	Needs Follow Up	No water at time of inspection.
142.	Range/Oven	Needs Repair	Electric. Missing correct anti tipping bracket, a safety device which is required by the manufacturer and Consumer Product Safety Commission. Range will not slide back to wall.
143.	Exhaust Fan	Functional	
144.	Washer	Needs Follow Up	The water was not on at time of inspection.
145.	Dryer	Needs Repair	Electric. Exterior hood with back draft flapper is damaged or missing.
