**McCabe Home Inspection Services Inc**  
 Lake Worth FL  
 Licenses HI901 CBC058559 CCC058824 CPCO JF112319  
 Ph#: (561) 547-9870

Doc #: Inspector: David McCabe

Date: 3/22/2019

Dwelling Address: 1975 Claybridge Circle  
 West Palm Beach, FL

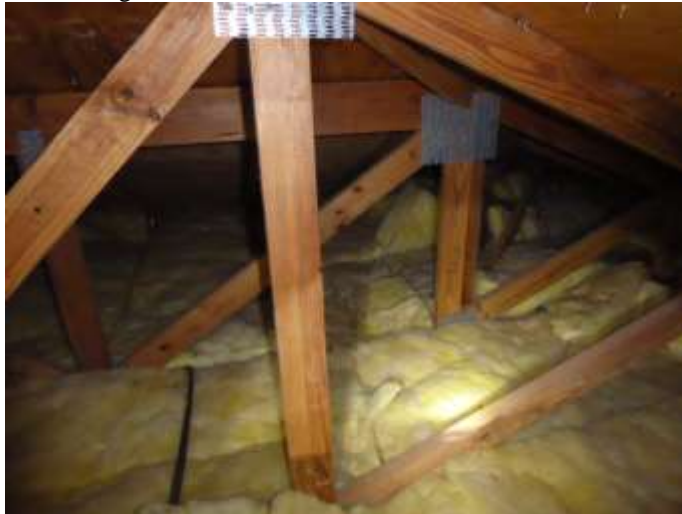
29. Ventilation Functional Soffit vents. This is passive ventilation based on cooler air coming in the soffit screens to lower the attic temperature. Vents high up in the attic to release hot air such as ridge and turbines are desirable.

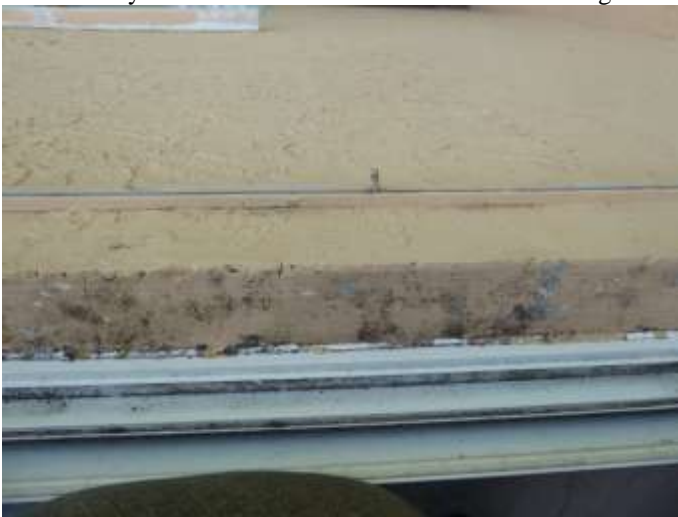
35. Trim Functional House has Deco trim which is an ornamental feature usually consisting of solid stucco or Styrofoam with a cementitious / stucco coating.

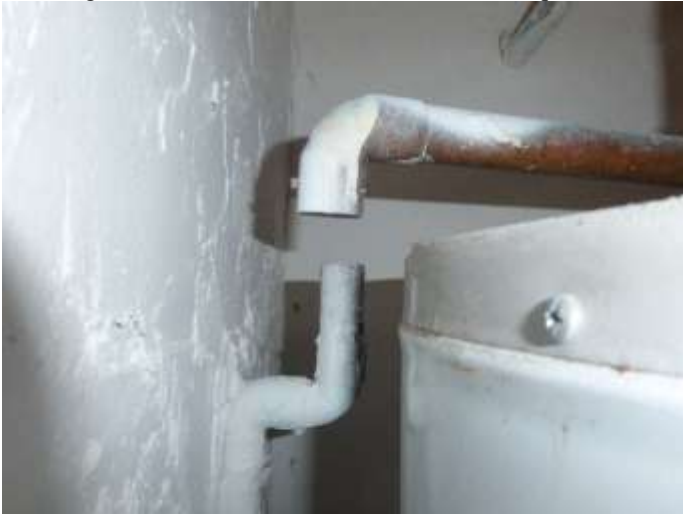
Step #	Component	Rating	Comment
73.	Supply pipes	Functional	Copper. All visible piping was copper.
74.	Waste pipes	Functional	PVC. All visible piping was PVC.
75.	Main shut-off	Needs Follow Up	Brass gate valve.
76.	Water flow	Needs Follow Up	City water. Water was off at time of inspection.
77.	Drain flow	Needs Follow Up	City sewers.
78.	Water heater	Needs Follow Up	Rheem, 50 gal. 12 years old. Water was off at time of inspection.  Older water heater at end of expected life span. Recommend client budgets for replacement.
80.	TPR valve	Needs Repair	Discharge line is not within 6 inches of floor as required for safety in any location.
